Biological Resources Assessment
Technical Memorandum
(EDAW 2009)

Technical Memorandum

Date: June 18, 2009
To: Carmel Brown, CKB Consulting
From: Debra Bishop, Chris Fitzer, and Matt Wacker, EDAW
Subject: Laguna Creek Watershed Protection Program, Biological Assessment Findings

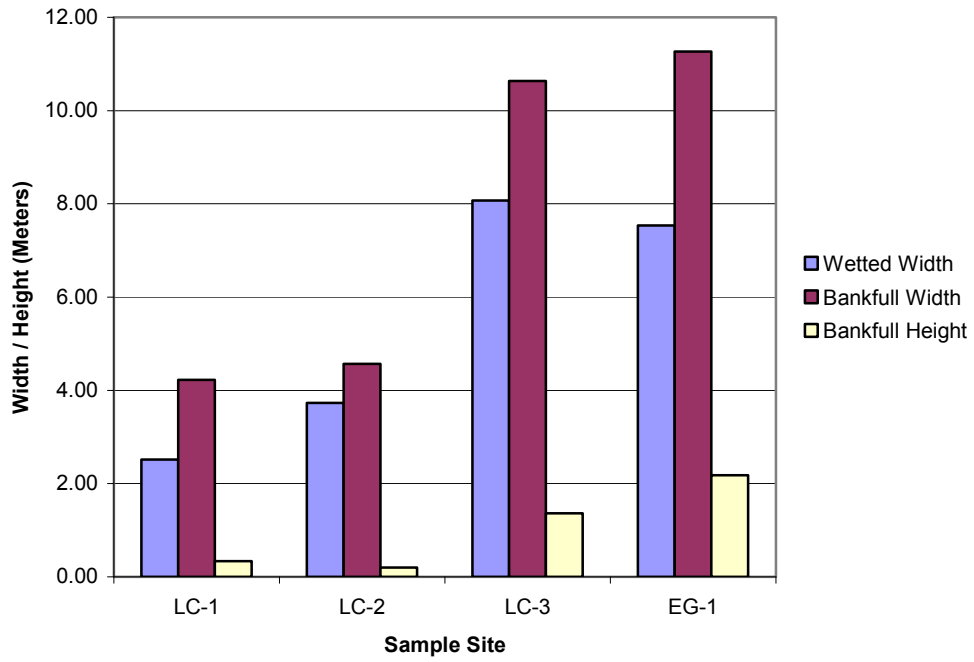
Exhibit 6

Mean Channel Dimensions by Reach

Transect and intertransect measures of physical habitat parameters indicated that the four reaches surveyed in the watershed can be characterized by varying conditions. Common characteristics of all of the reaches surveyed included low riparian canopy cover and low gradient; all other parameters varied substantially.

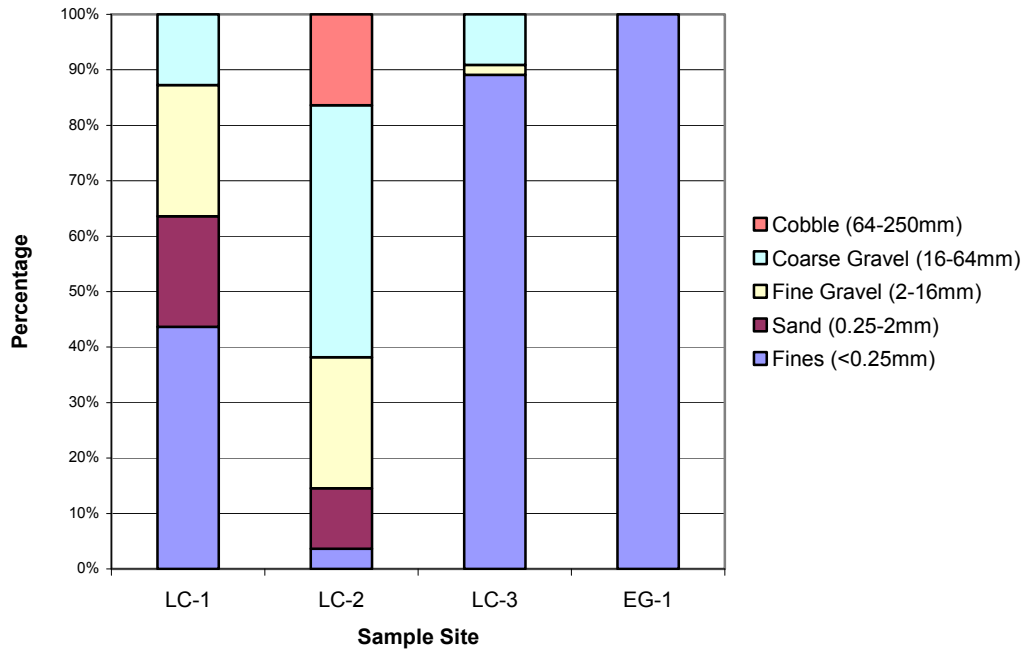
Exhibit 8

Substrate Size Class Abundance by Reach

Substrate class sizes recorded at LC-1 included fines, sand, fine gravel, and coarse gravel, with fines being the most dominant class recorded (44%). Substrates at LC-2 included a range of more coarse material (fines to cobble), with coarse gravel being the dominant size class (45%). Both LC-3 and EG-1 reaches were dominated by fines. Embeddedness was recorded for all substrates in the fine gravel class or larger. Embeddedness ranged from 45% to 56% between sites LC-1, LC-2, and LC-3. No fine gravel or larger class sizes were recorded at EG-1; therefore, embeddedness was not recorded.

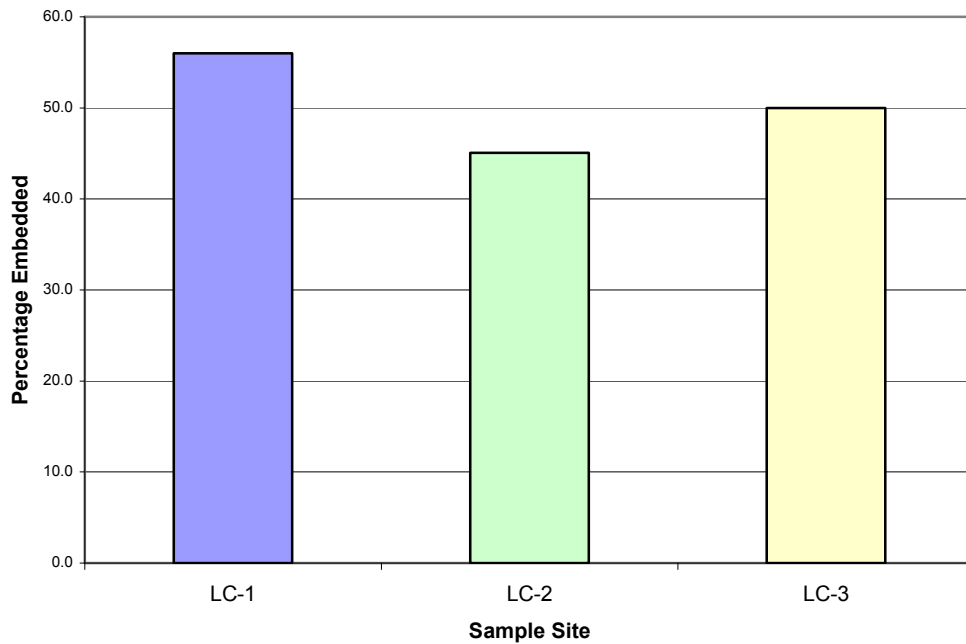
Exhibit 9

Note: Cobble in LC-3 was documented to be artificial construction material; no cobble was documented in EG-1.

Cobble Embeddedness by Reach

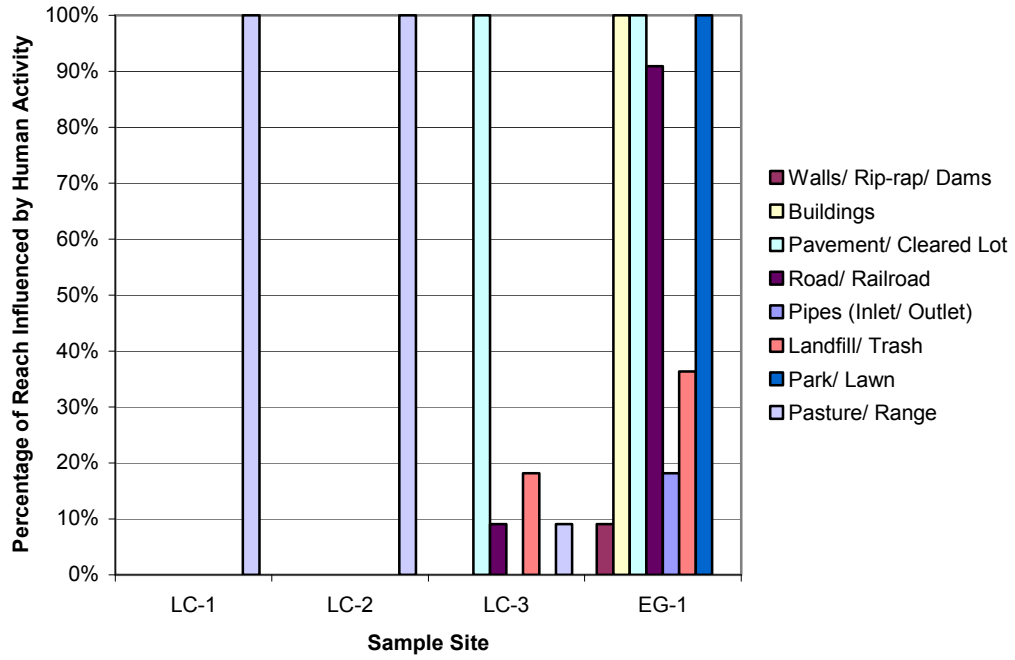
Exhibit 10

Human Influence by Reach

The amount and type of human influence on each reach varied dramatically. Pasture/rangeland was the sole human influence recorded at both LC-1 and LC-2. Cattle were present at both reaches during the times of the surveys at these more rural locations within the watershed. LC-3 exhibited more urban/suburban influences, with pavement/cleared lot throughout the length of the reach. EG-1 exhibited a variety of human influences; buildings, pavement/cleared lot, roads, and park/lawn were the dominant class types.

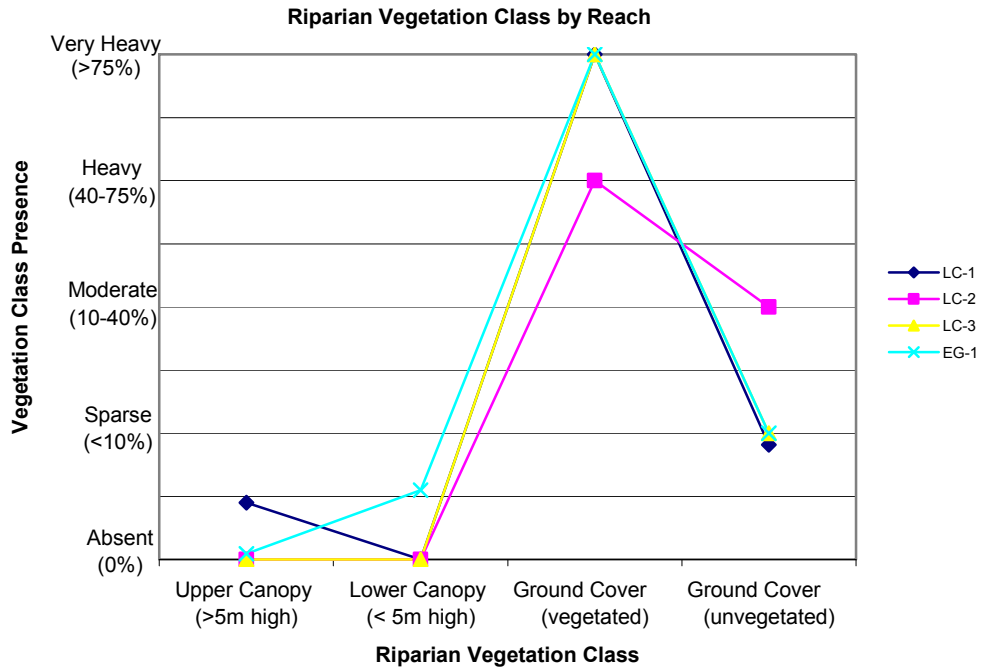
Exhibit 12

Riparian Vegetation Class by Reach

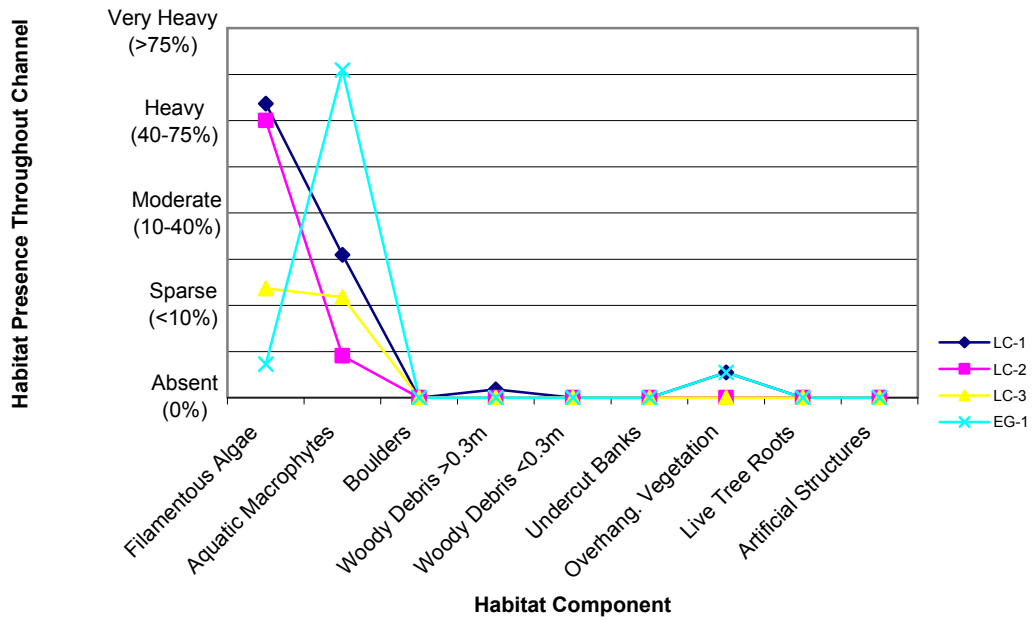
Exhibit 13

Instream Habitat Complexity by Reach

The dominant form of instream habitat complexity at both LC-1 and LC-2 was filamentous algae; aquatic macrophytes were also present to a lesser degree. The extensive growth of filamentous algae at both LC-1 and LC-2 can perhaps be attributed to the presence of cattle (and associated feces) that can lead to nutrient loading in the creek. LC-3 also contained both algae and macrophytes, but filamentous algae was generally less dense. EG-1 was dominated by aquatic macrophytes (i.e., water primrose) and was nearly completely choked by this aquatic vegetation.

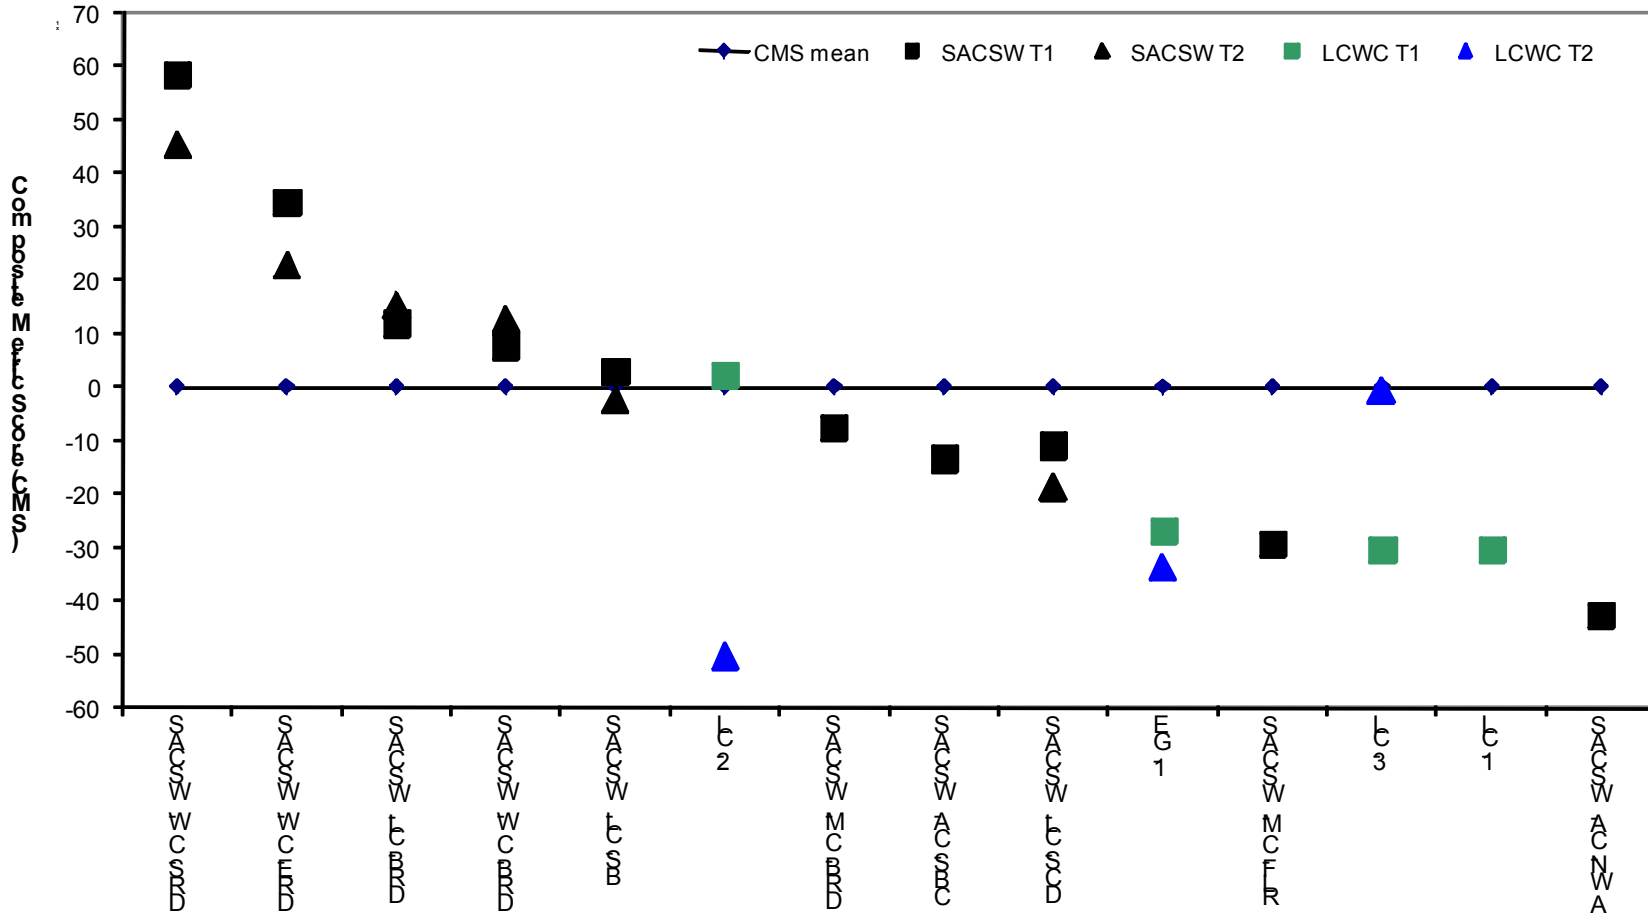
Ranked CMS Plot for Sacramento County Stream BMI Bioassessment Sites

Exhibits 22 and 23 plots Laguna Creek BMI CMS relative to other Sacramento County and Sacramento valley stream BMI scores, respectively. Relative to other Sacramento County and valley streams, Laguna Creek Watershed streams exhibit intermediate to poor quality conditions as measures using CMS analysis with the 14 metrics that were determined to be most discriminant.
